Concrete House Stands up to Katrina

Full Mitigation Best Practice Story

Harrison County, Mississippi

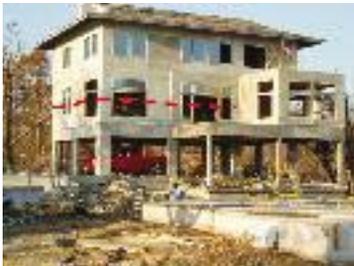
Photo Caption 1: The water line was at 28 ft. as indicated by the red line in this photo. Photo Caption 2: This photo clearly shows the concrete post and beam construction that supports the 3,000 sq ft structure. Photo 1 courtesy of the Mitigation Assessment Team. Photo 2 courtesy of John Fleck.

The water line was at 28 ft. as indicated by the red line in this photo.

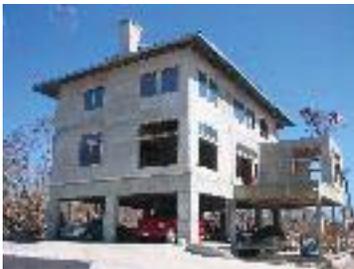
Stronger building materials and techniques proved effective during Hurricane Katrina.

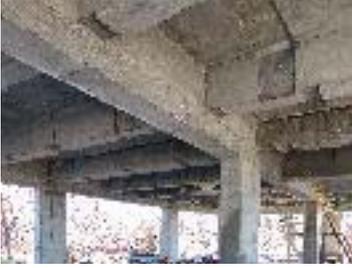
Concrete post and beam construction.

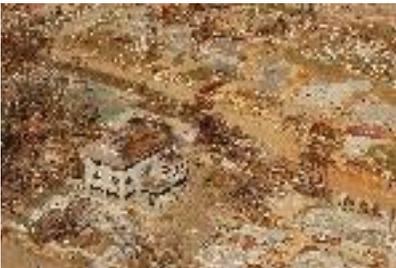
Aerial View of the Surrounding Destruction in Pass Christian, Mississippi.
